Ingersoll Water System: Water Quality

Public Works Department
November 26, 2012

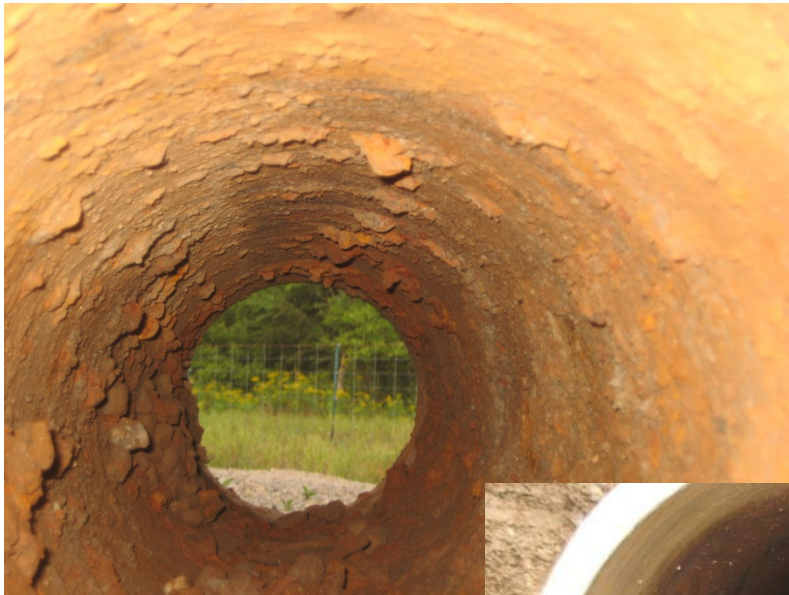
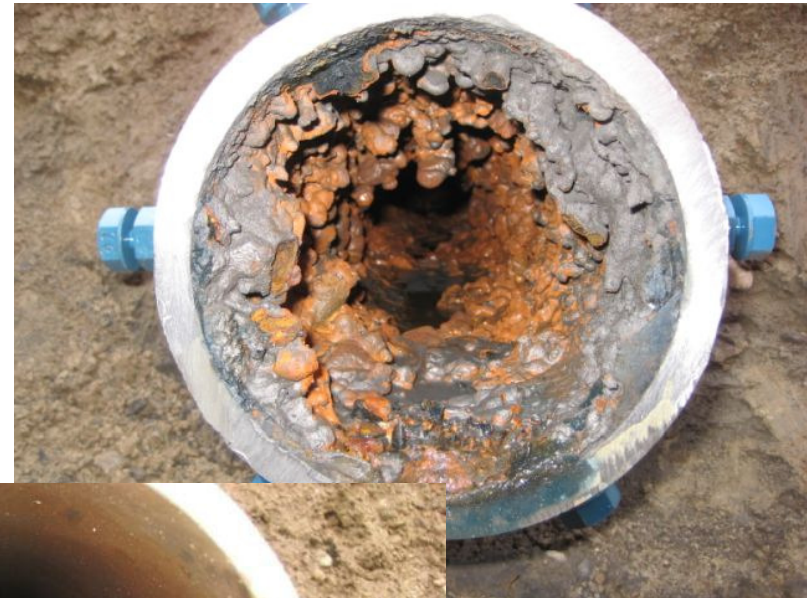
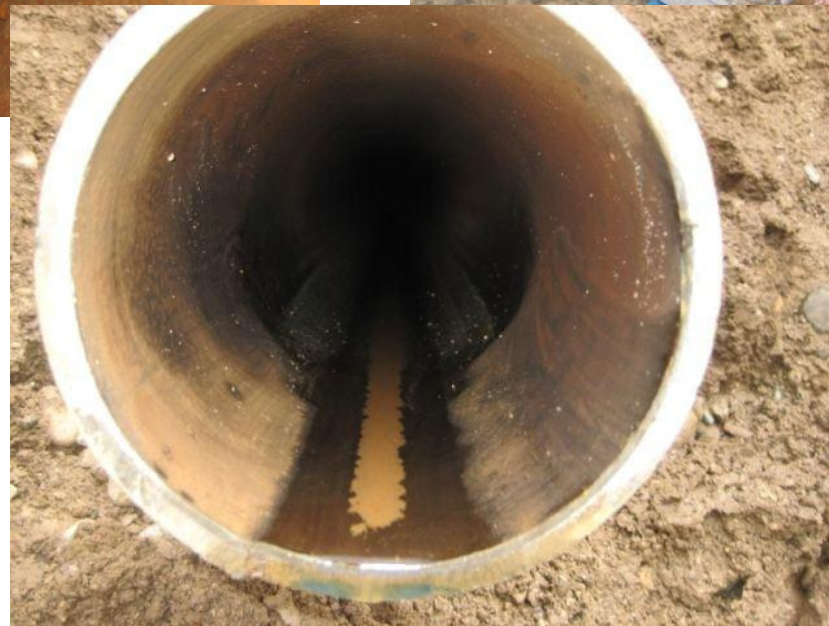
Older Watermains

- Has been a historical issue in Ingersoll
- Due to:
 - Insufficient flow in watermains (stagnant) – reacts with pipe wall
 - High flowrate (fires, watermain breaks) – strips sediments/tuberculation from pipe wall
 - Water quality changes (pH, alkalinity, H₂S)
- More prevalent in areas with old cast iron watermains

- Common pipe material used into the 1960s
- Replaced by ductile iron and more recently PVC pipe
- Unlined: water reacted with pipe wall to form corrosion tubercules
- Recent change in treated water quality (lower levels of H₂S, higher levels of chlorine residual, lower pH)
 - Started re-dissolving/loosening tuberculation
 - Dissipated chlorine residual
 - Worse in locations with poor circulation

- Reline or replace existing cast iron or unlined ductile iron pipe
- Estimate: 14 km of watermain
- \$5.5 – \$7.0M over 4 to 5 yrs
